Successful Noise Control Cases 2001

SUCCESSFUL CASES OF NOISE CONTROL

OCCUPATIONAL SAFETY AND HEALTH DIVISION

MINISTRY OF MANPOWER

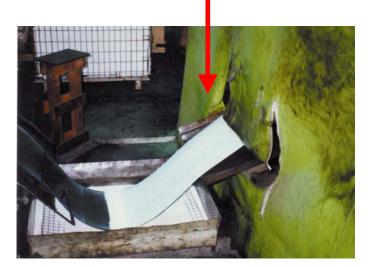
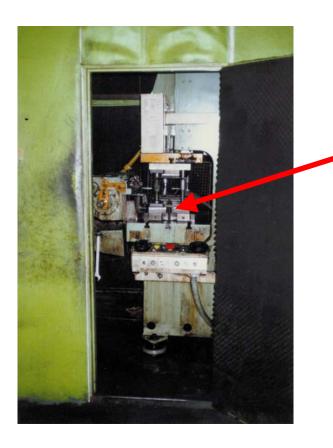
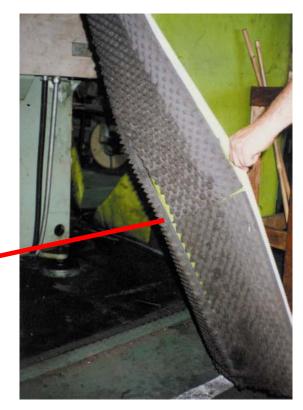
1. Total Enclosure of Perforation Machine

An automatic machine was used to perforate steel sheets. The noise produced was continuous with impact intervals at less than 1 second. The noise level was in the range of 98 to 105dBA.

Inlet of perforation machine

Outlet chute of machine

Machine housed in enclosure

Inner walls lined with acoustic materials

A total enclosure was constructed to enclose the perforating process using plastic sheet with reinforced wire mesh. The inner walls of the enclosure were lined with acoustic material, polyurethane foam. This resulted in a 20 dBA noise reduction.

After installation of the enclosure the noise level outside the enclosure was 80 dBA.

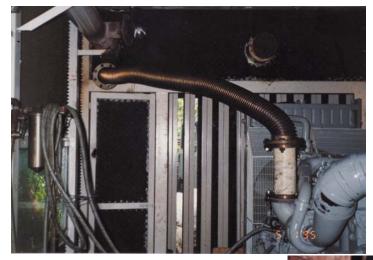
Inner walls of test cabin

Acoustic materials (polyurethane foam)

A test cabin was constructed to house the engines for testing. The cabin was constructed of sheet metals with interior surfaces lined with polyurethane foam. Exhaust ducting with silencers was provided. A control room for a technician is also integrated into the cabin.

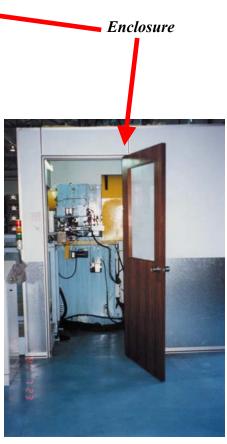
5. Total Enclosure for Iron Cutting Machine

A worker checking on process through window

Door for easy access to machine

Part of the machine was enclosed using a 12mm gypsum board and galvanised stud with fibreglass insulation in the partition. External surface of enclosure is a 1mm galvanise sheet. A door and window were built in to facilitate easy maintenance.

A noise reduction of 7 dBA was achieved.

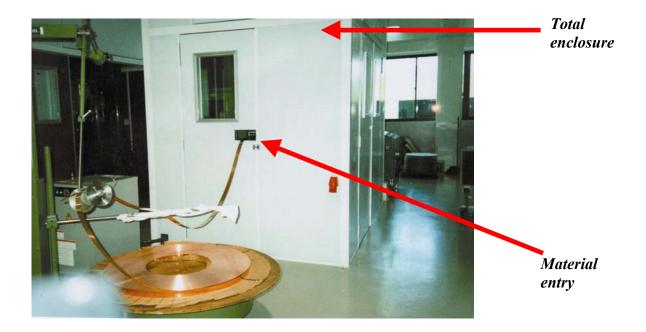
6. Total Enclosure for Stamping Machine

Noise level of 90 dBA was generated from a stamping machine. The process was automatic and requires minimal supervision from workers. However, the stamping machine is located in the middle of the production floor posing a noise hazard to other workers.

A total enclosure was installed for the stamping machine. Doors and windows were incorporated for easy access and production control. The enclosure was constructed of a 1.25cm thick hardboard and packed with a layer of fibreglass of 5cm in thickness.

A noise reduction of 10 dBA was obtained.

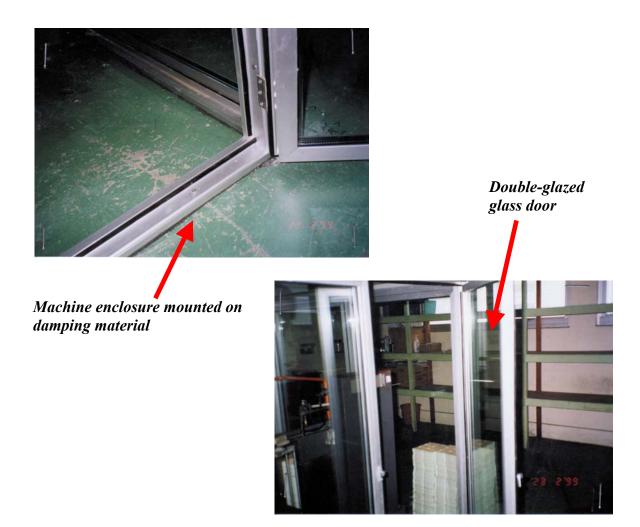
8. Total Enclosure for Automatic Insertion Machine

Auto insertion machine without enclosure

Acoustic material for ceiling of enclosure

The machine was enclosed with steel sheet. The inner walls were lined with a 30mm thick sound absorbing material. Operators access was enclosed using double-glazed glass with vacuum in between. All gaps were sealed with rubber sealant.

The noise levels were measure to 70 dBA after installation of enclosure. A noise reduction of 15 dBA.

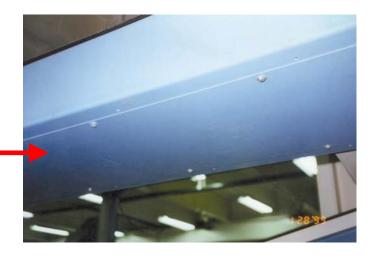
12. Total Enclosure for Conveyor Belt

An overhead conveyor belt used to transport bounded printed items emits a noise level of 82 dBA.

Covers to underside of conveyor belt

Metal covers were installed on the underside of the conveyor belts.

A noise reduction of 7 dBA was achieved with the installation of the metal covers.

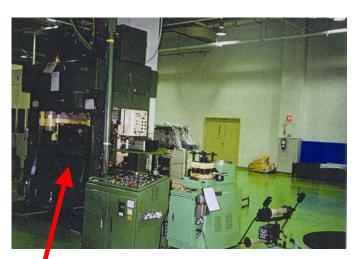
Stamping machine

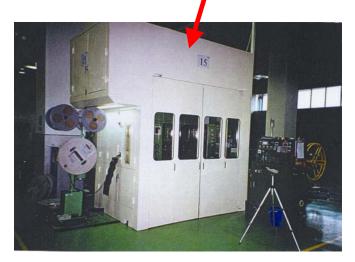
Total enclosure

A total enclosure was constructed for the stamping machine.

An average noise reduction of 13 dBA was recorded.

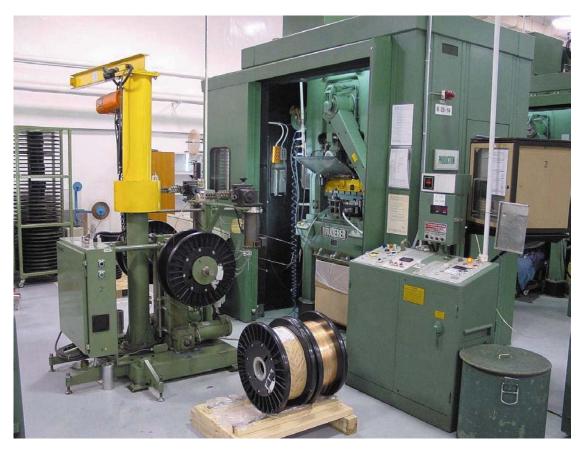
Photograph of a high-speed reel-to-reel stamping machine.

A total enclosure of the stamping machine was installed. The unique feature incorporated into the design was the portability of enclosure. This feature allows the worker to monitor the stamping process without leaving the enclosure door open, hence reducing the noise exposure to other workers.

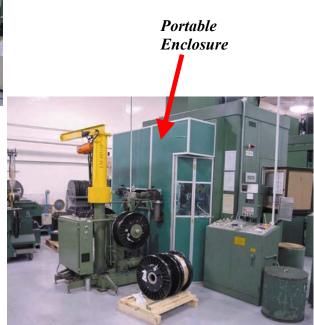
Enclosure door opened

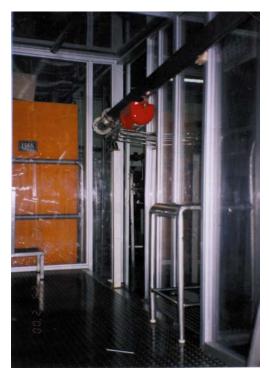
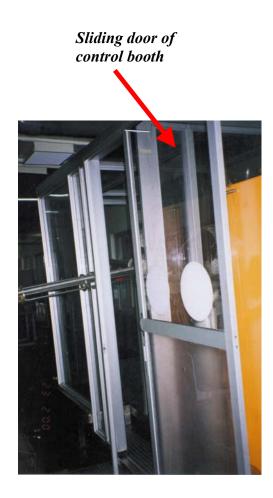
21. Acoustic Curtain for Filling and Lid Seaming

Noise was generated during the filling and seaming process of drink cans. Noise level before control measure was 92 dBA.

Rear view of machine

Pathway to control booth

Acoustic curtains made of thick plastic sheets were used to enclose the filling and lid seaming process. Workers were isolated in a control booth.

A noise reduction of 3 dBA was achieved.

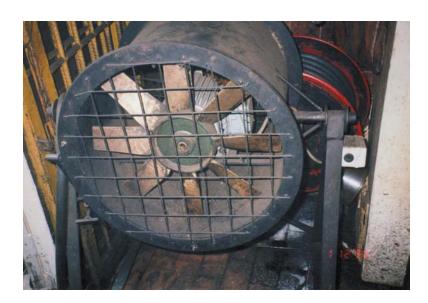
The axial flow blowers were used for cooling of coffee beans. The noise level generated from this process was 90 dBA.

Axial-flow fan

The axial-flow fans were replaced with blowers of lower horsepower. The new blowers were also covered with meshed metallic gauze to reduce noise.

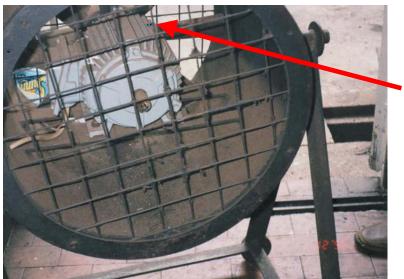
High capacity horsepower motor

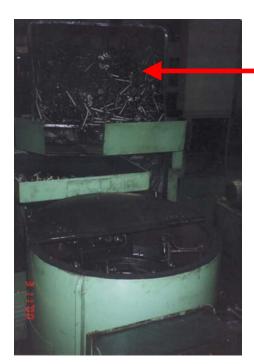
Excessive noise was generated from tumbling crankshafts and a vibratory bowl feeder. The noise from the process was 90 dB(A).

Tumbling crankshafts being fed into vibratory bowl

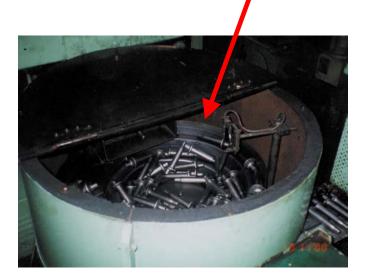
Polyurethane layer on receiving tray

Redesigned bowl feeder

The crankshaft receiving trays were lined with a 1mm thick layer of polyurethane to reduce the impact of tumbling crankshafts and hence the noise level. The vibratory bowl feeder was redesigned to a quieter rotating bowl feeder.

The noise level generated after commissioning of the new machine was 75 dBA. This is a reduction of 15 dBA.

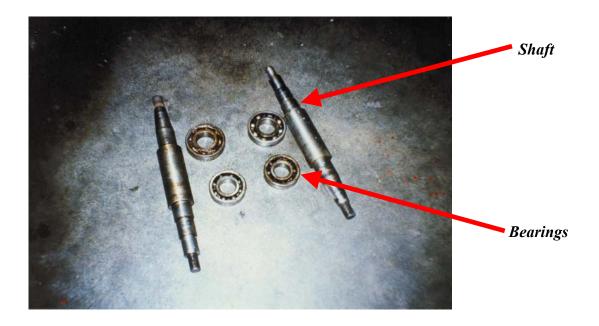
Centrifugal Separator

Four centrifugal separators were used in a factory that manufactured refined eucalyptus oil. The noise level from one of the centrifugal separators was found to be producing a noise level of 96 dBA. The other separators were around 83 dBA. Noise was also generated from a vibrating drainage pipe which was in contact with a hard surface.

The centrifugal separator in question was sent for repairs and servicing. The driving shafts and bearings were also replaced. The vibrating drainage pipe was isolated from the hard surface to reduce noise generation.
